260-IN.-DIA MOTOR FEASIBILITY
DEMONSTRATION PROGRAM (u)

STATIC TEST FIRING OF MOTOR 260-SL-2
FINAL REPORT

NASA CR-54982

25 MARCH 1966

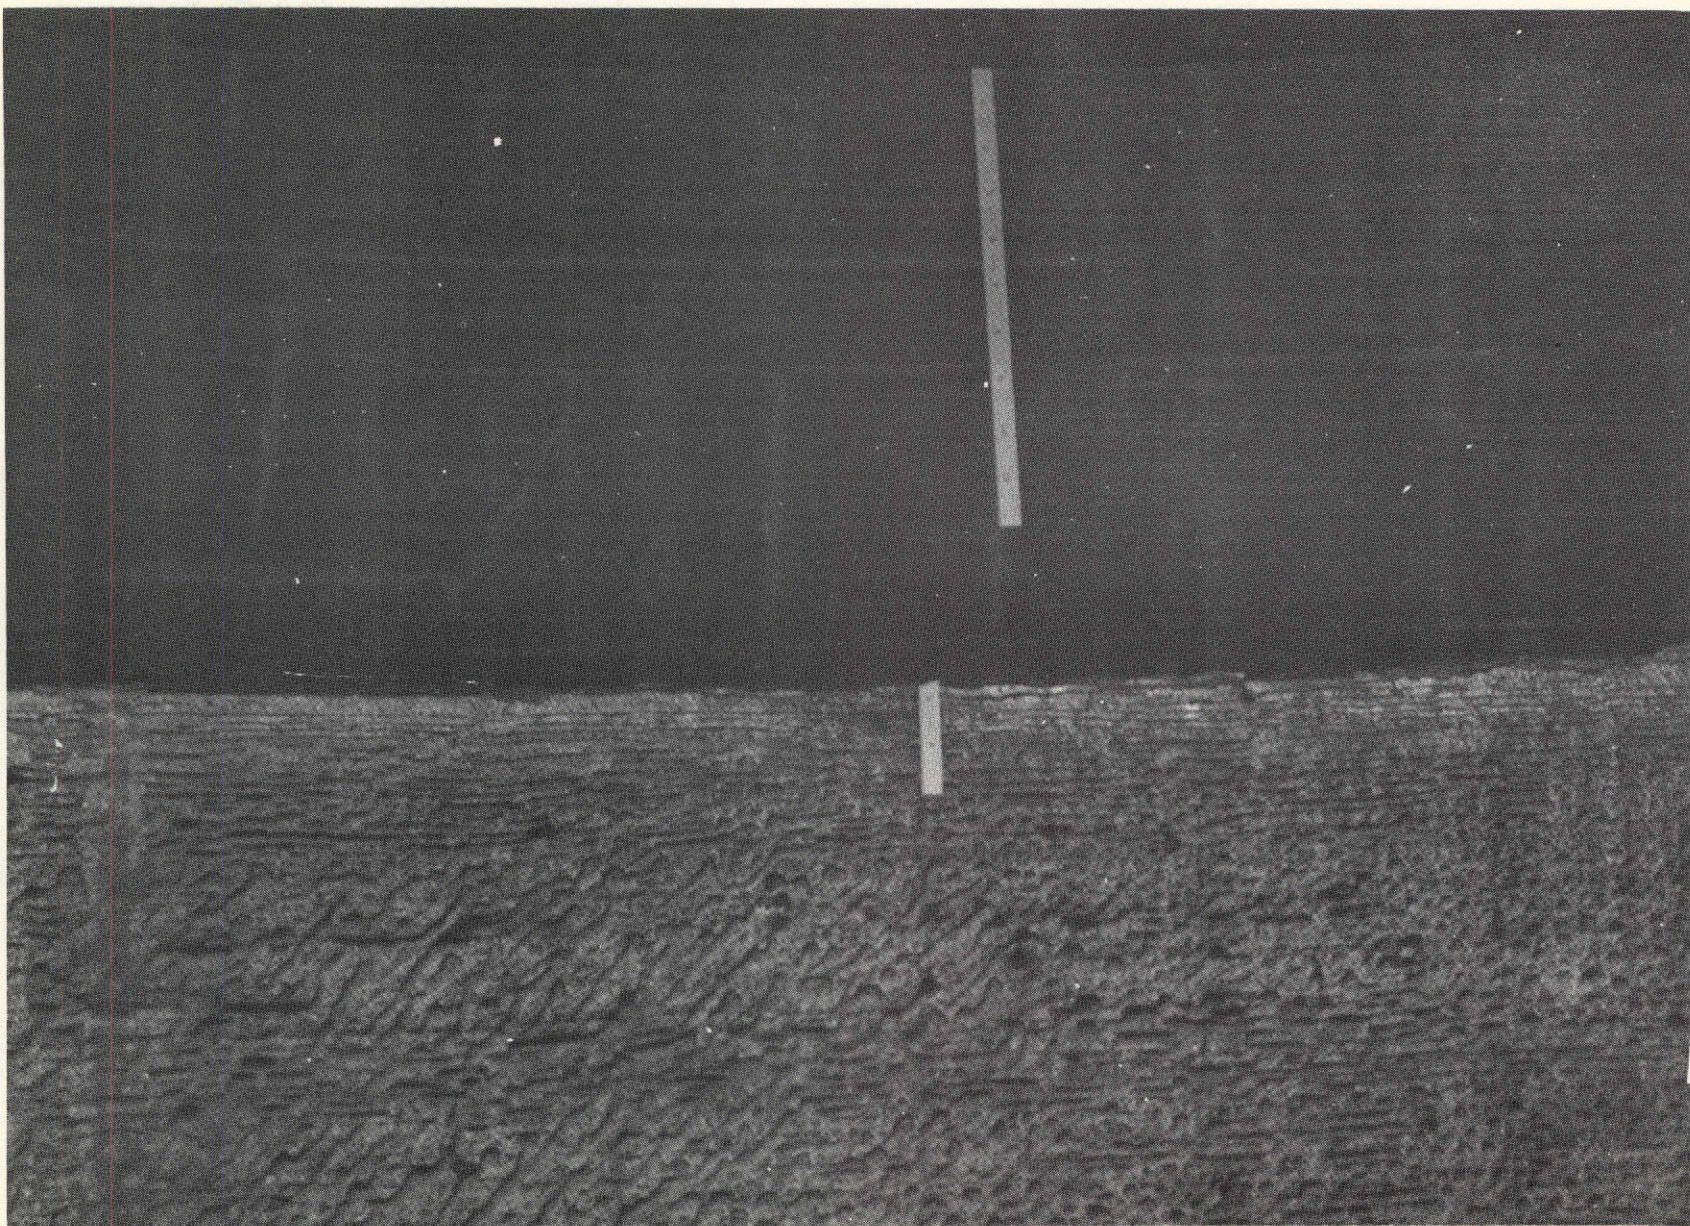
Posttest View of Exit-Cone Ablation Surface

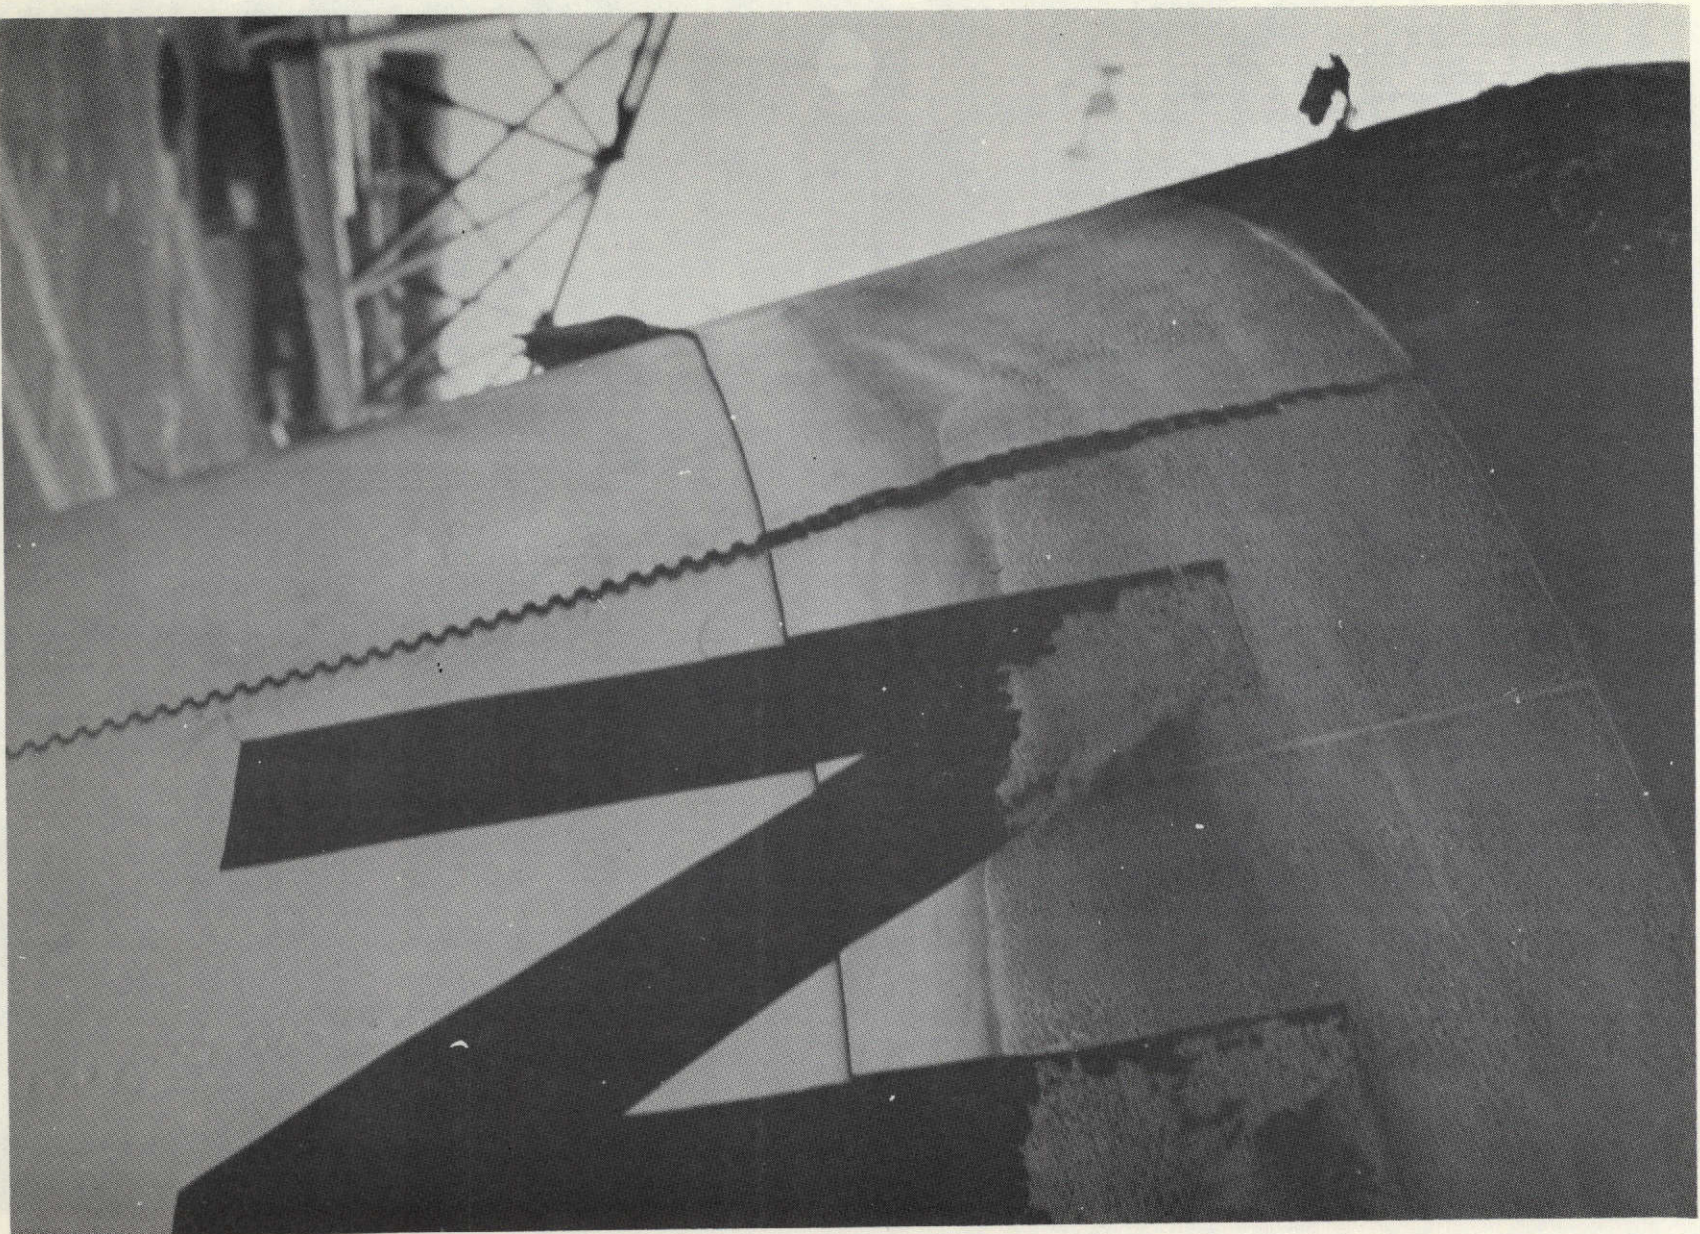
Posttest View of Exit-Cone Exterior

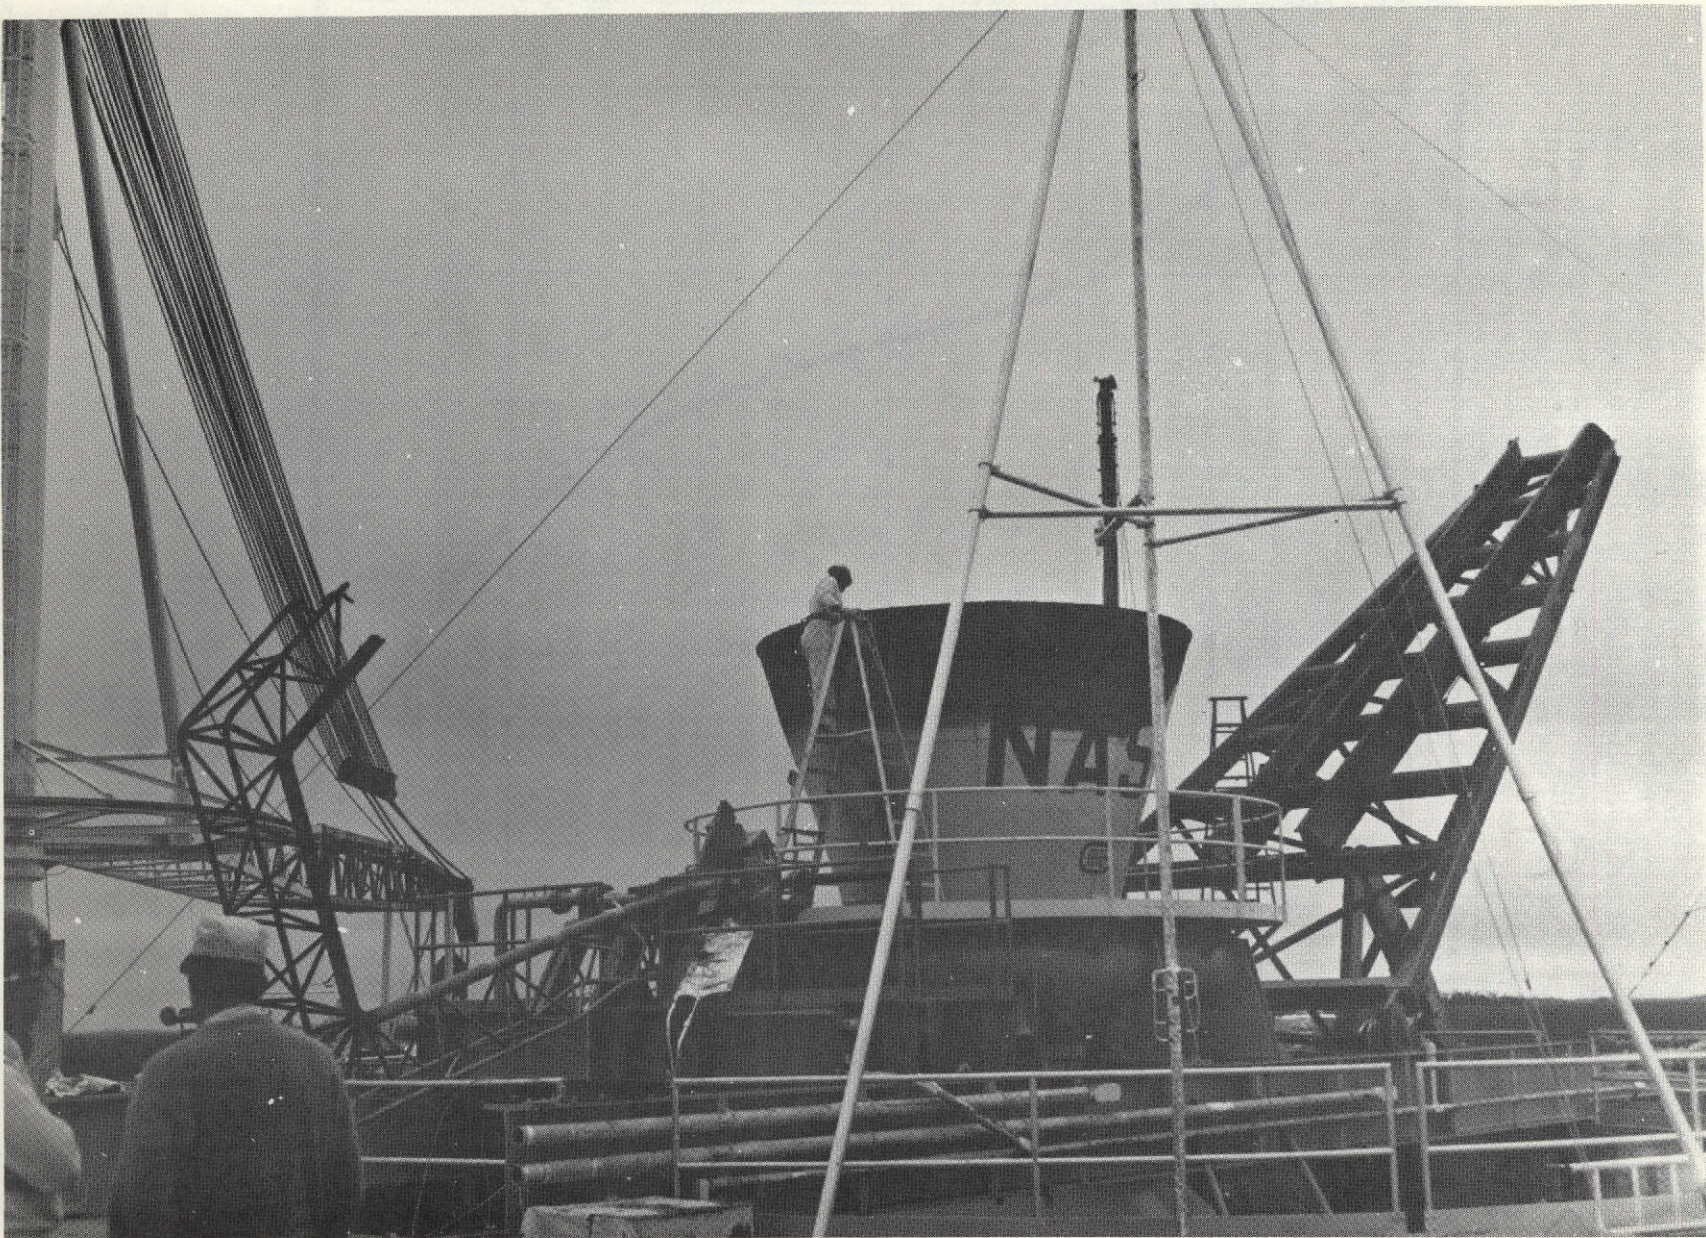
Posttest View of Ignition Motor Track Assembly
